Sell Home Inspections Inc

SUMMARY REPORT

Inspection Address: 1234 Any Street, , Arizona 12345
Inspection Date: 9/15/2015 Start: 1:00 pm End: 4:30 pm
Weather: Overcast
Temperature: 90-100 Degrees

Inspected by: Rob Sell AZ Certification 38865

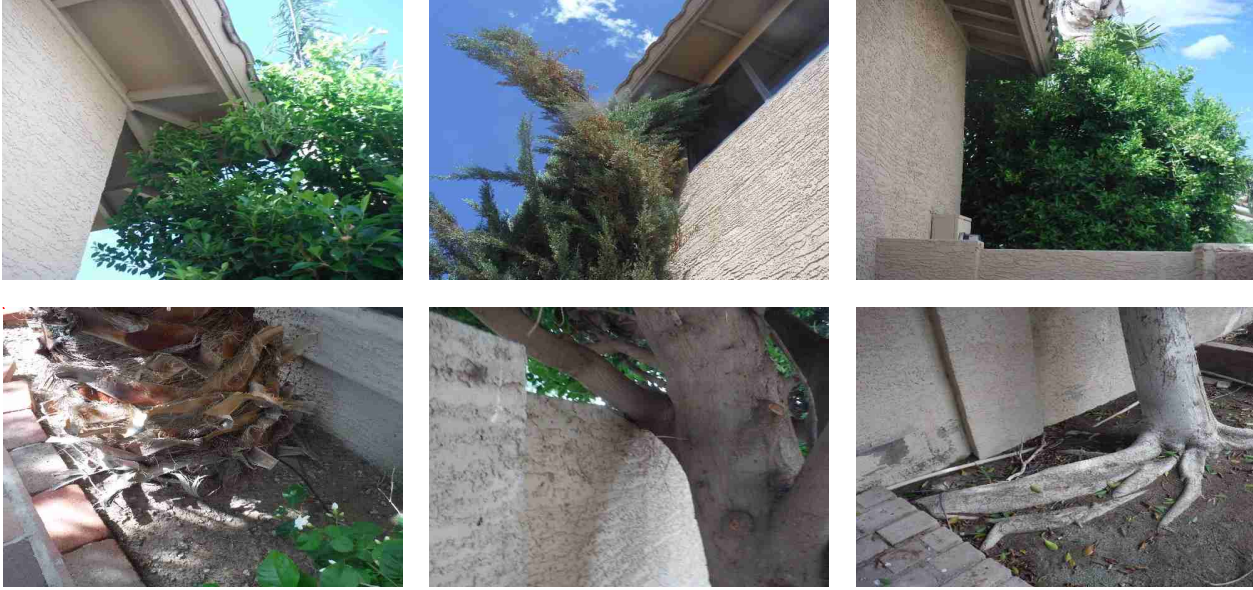
2.1 - The trees located at the following location is in direct contact with the residence and need to be removed/trimmed.

1. The north east exterior.
2. The south side exterior pine tree.
3. The south east exterior.

4. The south west exterior palm tree.

Note: The palm tree located at southwest exterior is planted to close to foundation and needs to be removed to prevent damage to foundation.

Additional Note: The ficus tree at south east exterior is pushing fence and additionally roots are growing under brick pavers. It may be necessary to remove tree to prevent further growth and potential damage to masonry perimeter fence.

Recommended Action: It is recommended that measures be taken to retain the services of a qualified tree removal company to trim all trees away from the residence. Furthermore this is a routine maintenance choir that should be monitored and completed as needed or until the tree is removed.

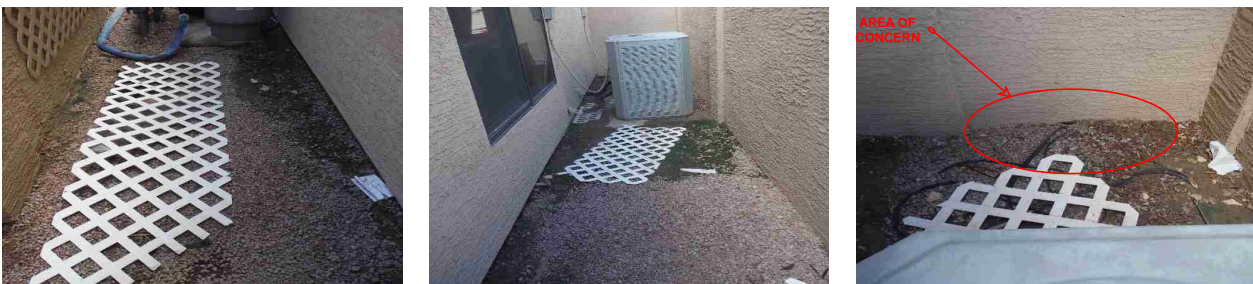
2.2 - The following area or areas at the subject property are creating a potential water ponding area and it is recommended that gutters or other industry standard approved moisture management systems be installed, by a qualified contractor, in the noted area to facilitate proper drainage and to further reduce the potential for moisture intrusion into the residence.

1. The east side exterior as their is no outlet for accumulated surface water as drain tile is obstructed by landscaping.

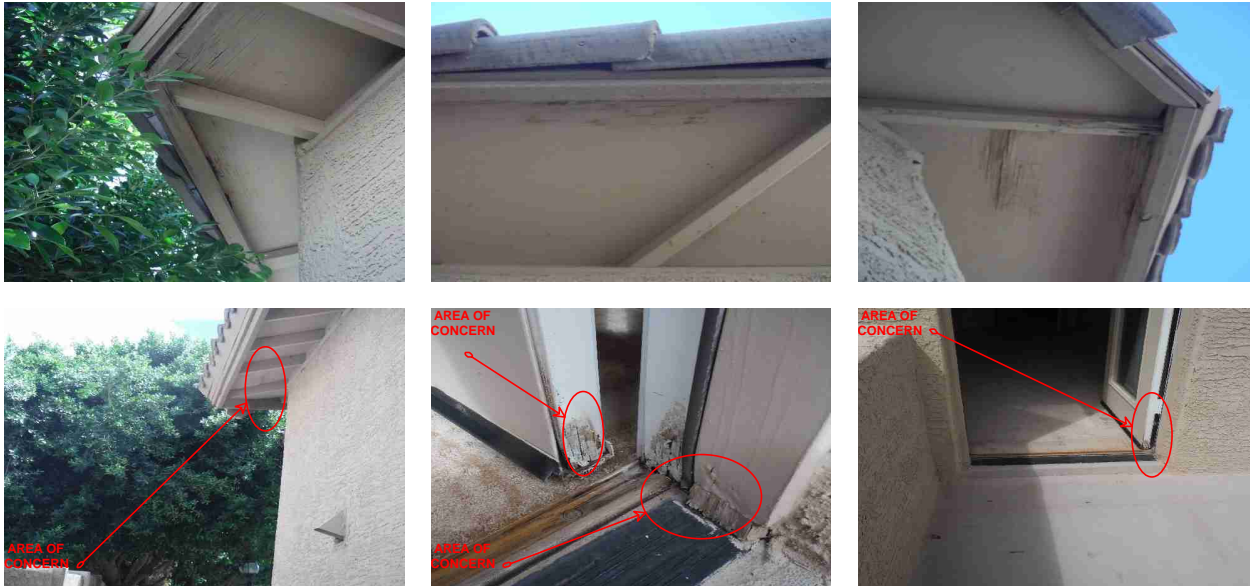
2.4 - There is moisture damaged wood at the following locations that needs to be repaired or replaced by a qualified contractor.

1. The south east roof sheathing.
2. The south side roof sheathing.
3. The south side roof sheathing and rafter tail.
4. The upstairs deck entry doors and lower jamb.

There is moisture damaged wood at the following locations that needs to be repaired or replaced by a - *Continued*

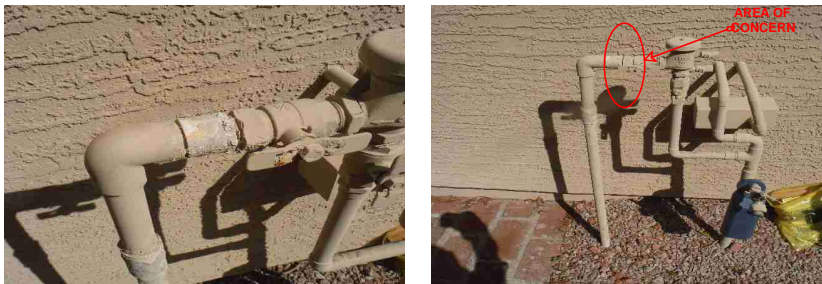
2.6 - There is leak at the water distribution pipe fitting where it is attached to the vacuum breaker that needs to be repaired by a qualified contractor.

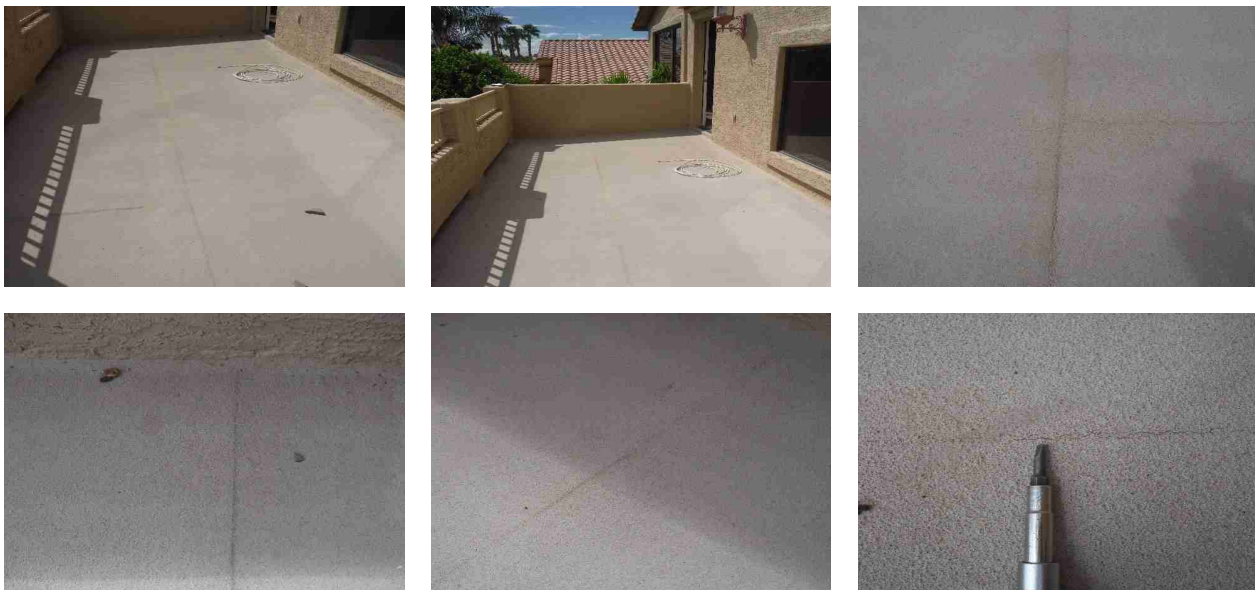
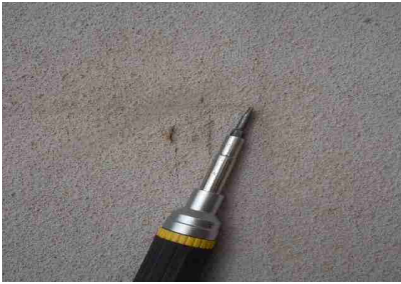
3.3 - The view deck covering material is cracked and separated at the seams at multiple locations on the decks surface. This is consistent with a deck coating that has exceeded its service life and it is recommended that the service of a qualified roofing contractor be retained to examine the deck coating and all related deck components in its entirety and further make all necessary repairs, modifications and corrective measures needed.

The view deck covering material is cracked and separated at the seams - *Continued*

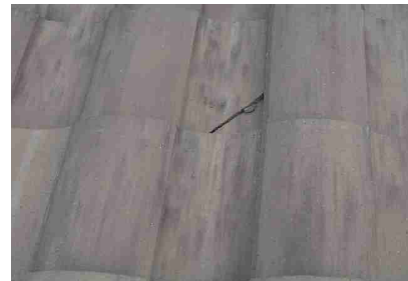
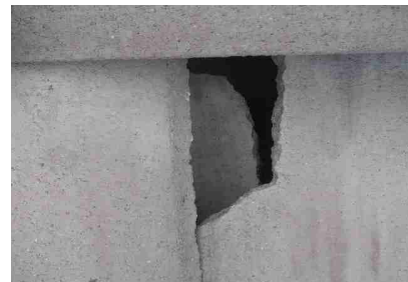
3.4 - There are multiple damaged concrete roofing tiles located at the following locations that needs to be repaired or replaced by a qualified contractor.

1. The east section of the roofs surface by deck.
2. The upper north east slope of the roofs surface.
3. The upper north east slope of the roofs surface.

Note: It is additionally recommended that the underlayment in the close proximity of the damaged tiles be evaluated and replaced as deemed necessary.

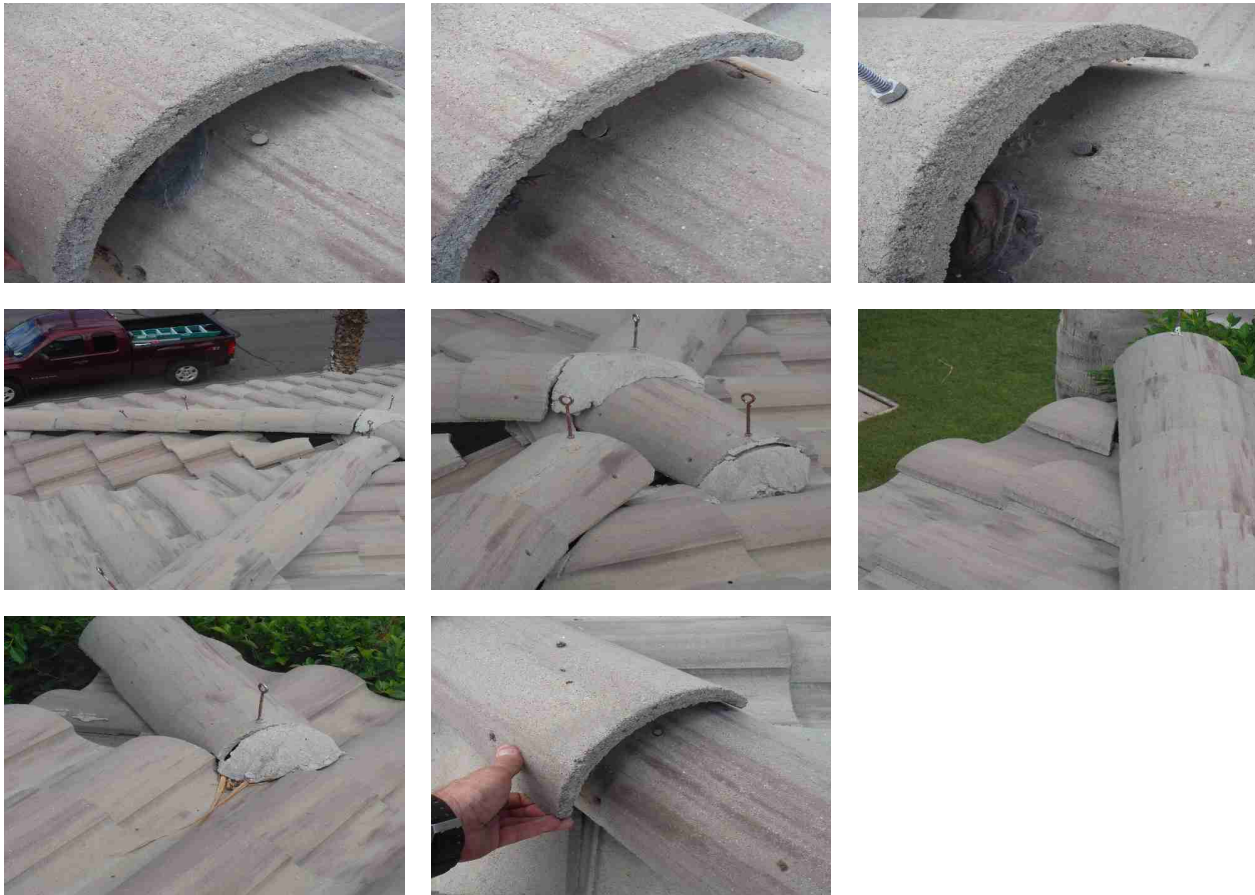
3.5 - There are multiple displaced concrete roofing tiles located at the following locations on the roofs surface that are further exposing the roofs underlayment.

Note: The ridge tiles are not properly secured as tile adhesive is deteriorated from exposure to the

elements and tiles can be moved using normal hand pressure. In addition, tiles were not nailed at any location that was checked; this includes all hip ridges and main ridge tiles.

Recommended Action: It is recommended that further examination and repair be conducted by a qualified roofing contractor.

Note: It is additionally recommended that the underlayment in the close proximity of the displaced tiles be evaluated and replaced as deemed necessary.

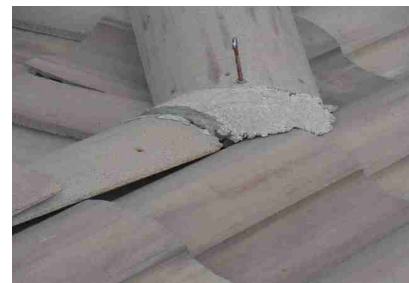
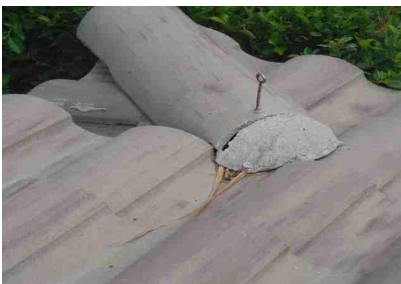
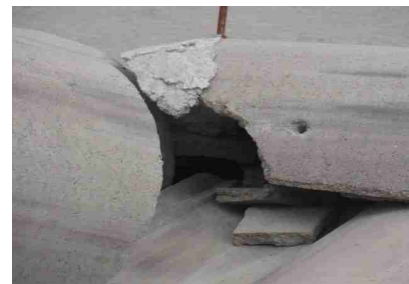
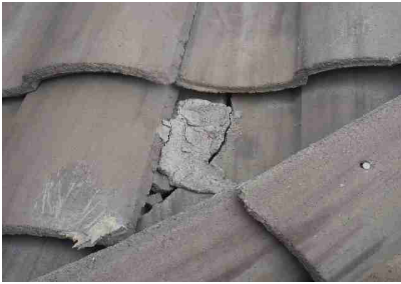
3.11 - The majority of the mortar caps were observed to be cracked and separated and need to be repaired by a qualified roofing contractor

The majority of the mortar caps were observed to be cracked and separated at - *Continued*

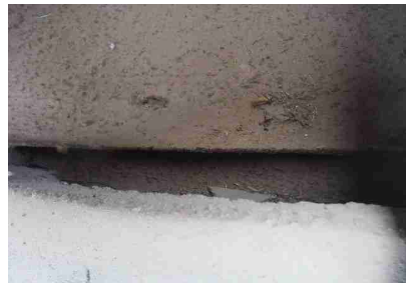
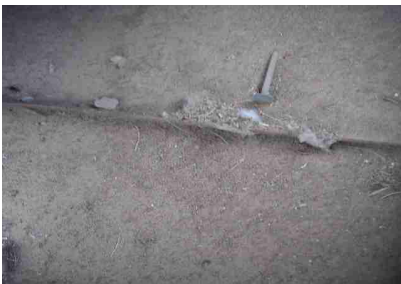
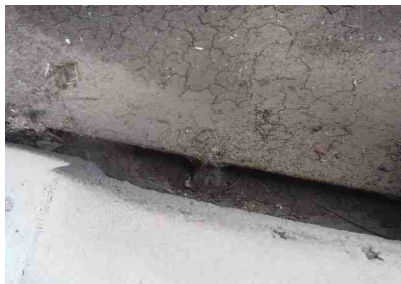
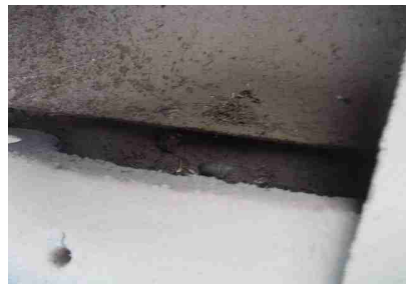
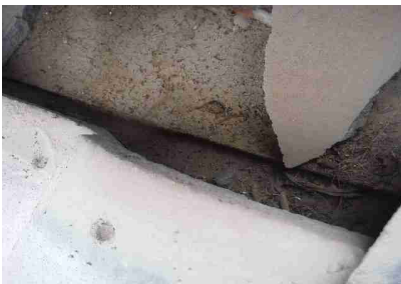
3.12 - The roofs underlayment was inspected and revealed an underlayment that is consistent with original. In addition, further inspection revealed the underlayment is brittle and curling at edges which is consistent with an underlayment that has exceeded approximately 85-95 % of its service life.
Recommended Action: It is recommended that further examination and repair or replacement as deemed necessary be conducted by a qualified roofing contractor.

Note: There is moisture staining on living room ceiling as described in the inspection report and further corroborating the underlayment is not performing its intended function shedding water.

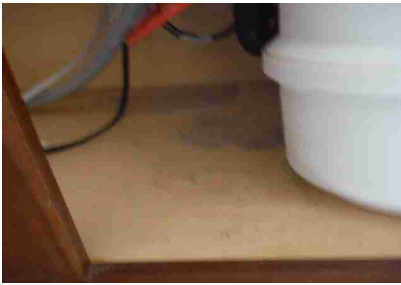
4.2 - There is evidence of moisture damage under the kitchen sink indicating which is consistent with a past leak. However, the extent of the damage could not be definitively determined as the concealed areas under the basin, and behind the walls cannot be observed. Therefore, it is recommended that measures be taken to retain a qualified contractor to repair the under sink basin area and all related cabinets and wall components in their entirety and further as deemed necessary. This may include but is not limited to a mold test if deemed necessary.

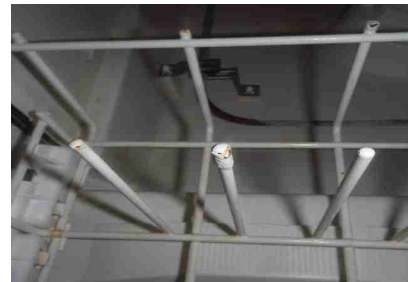
4.3 - The dishwashers racks are rusting which is consistent with dish racks that have exceeded their service life and need to be replaced by a qualified appliance technician.

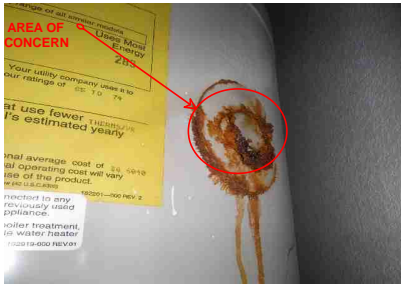
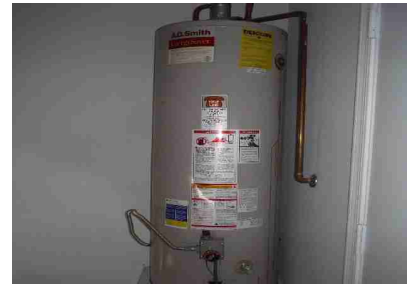
- 4.9 - There is **EXCESSIVE** rust at the upper drain plug of the hot water heater which is consistent with a water heater that is leaking intermittently and has exceeded its serviceable life.. This is an Immediate attention Item and it is recommended that the services of licensed plumbing contractor be retained to examine the water heater and to make the necessary repairs, modifications and corrective measures to include a total replacement of the water heater if deemed necessary.

Note: The hot water heater is leaking intermittently as stated above therefore, when gas is activated and hot water heater is ignited the water heater may leak excessively as water heater has exceeded its service life.

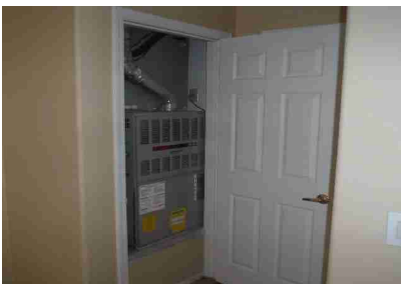
7.5 - The gas furnace access door is not equipped with combustion air vent ports which is not consistent with industry standards.
Recommended Action: It is recommended that further installation of vent ports in the natural gas furnace access doors be installed by a qualified contractor.

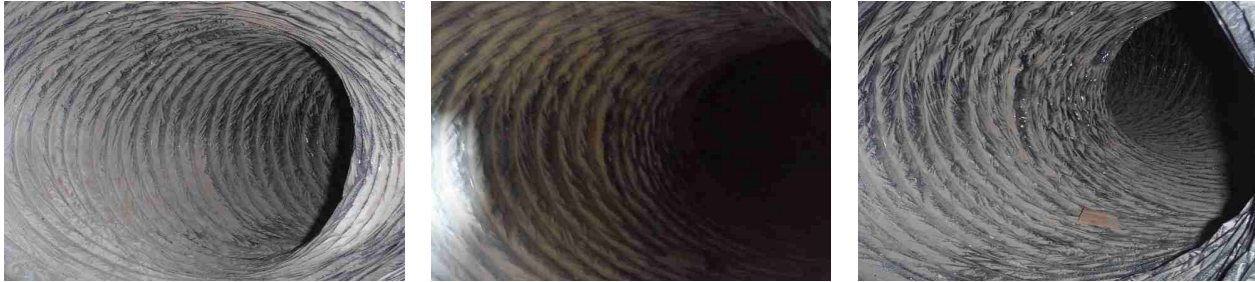
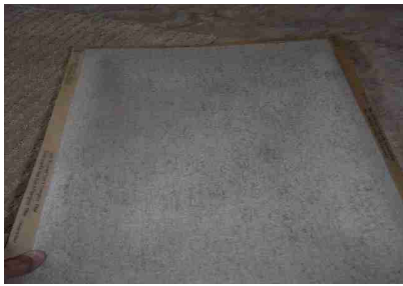
7.6 - The return air compartment, grill and ducts are atypically dirty indicating a lack of normal routine maintenance and it is recommended that the return air compartment and all adjoining ducts be professionally cleaned by a qualified duct cleaning company to reduce the potential for damage to the HVAC and its related components.

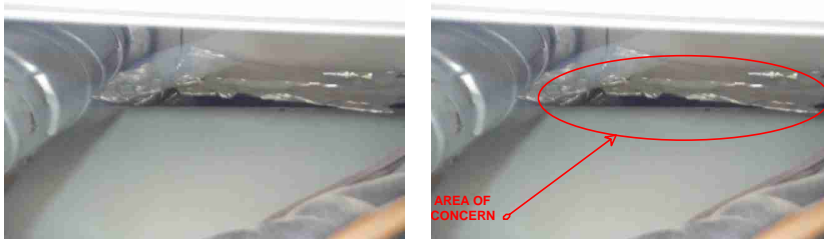
7.7 - There is an ACTIVE air leak at the HVAC air handlers plenum that needs to be repaired by a qualified HVAC contractor to prevent further energy loss.

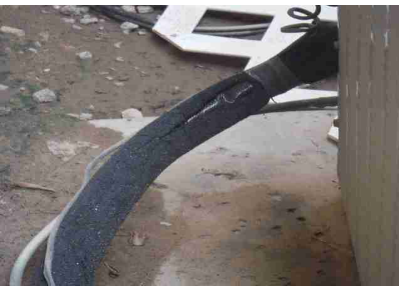
7.9 - Insulation is missing or deteriorated at the refrigerant lines at the condenser and needs to be replaced to operate and insulate the lines as intended.

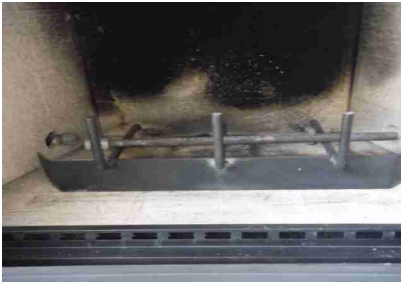
8.1 - The natural gas fireplace burner assembly has not been installed therefore, the fireplace is incomplete and needs to be repaired by a qualified general fireplace contractor.

The natural gas fireplace burner has not been installed therefore the fireplace is incomplete - *Continued*

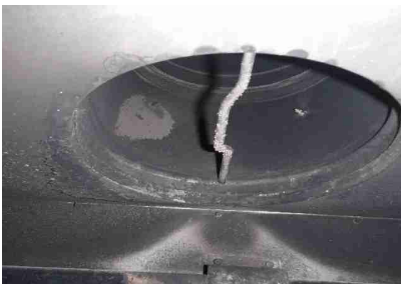
Note: If gas burners are installed damper must be installed in a fixed open position so it cannot be closed. This is to prevent back draft of combustion by products back into residence.

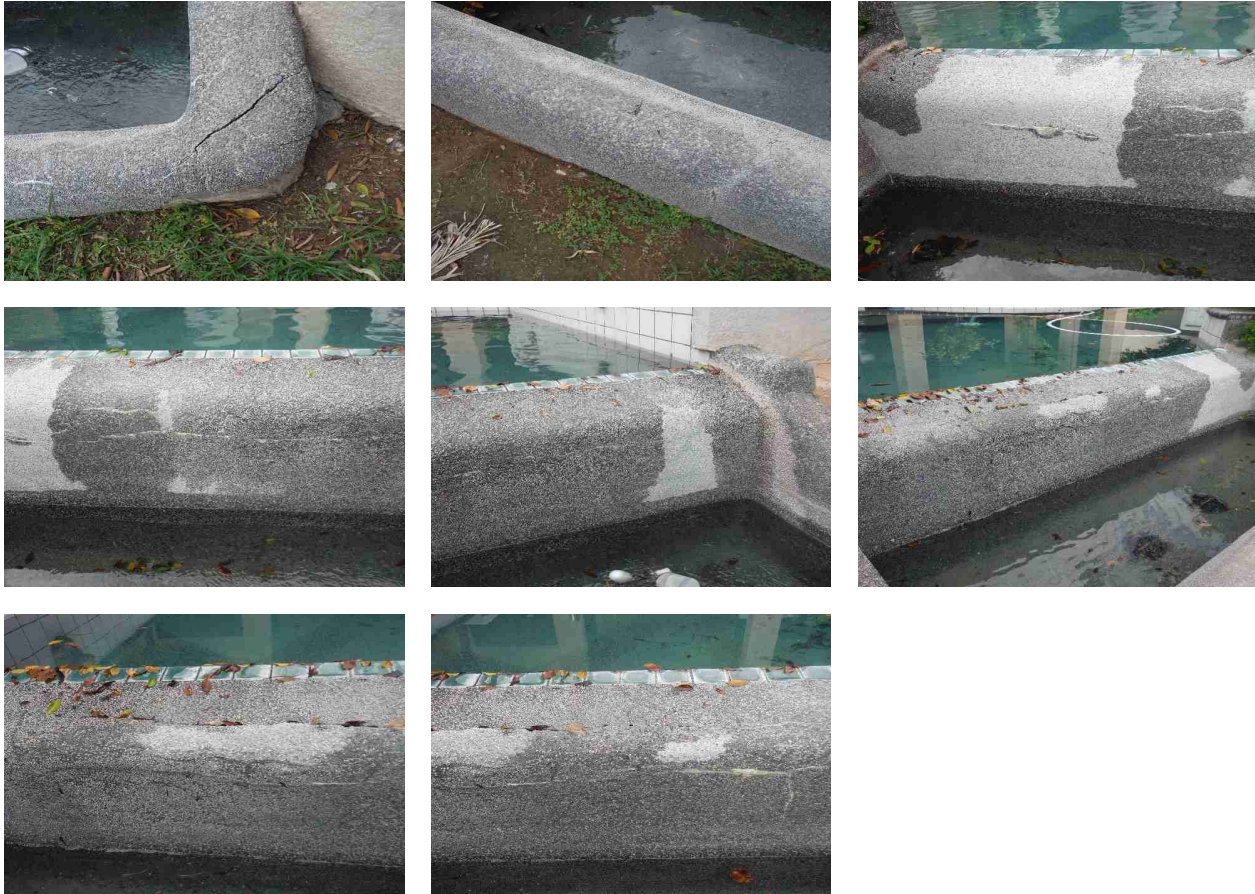
13.5 - The pebble tech at the pools negative edge areas are severally damaged at multiple locations as there are cracks in the pebble tech material. In addition, further inspection revealed extensive damage at south west section as water has entered behind pebble tech causing wall to deflect.

Recommended Action: It is recommended that further examination of the pools pebble tech materiel be examined and repaired by a qualified pool contractor.

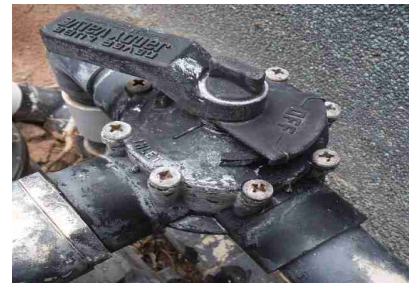
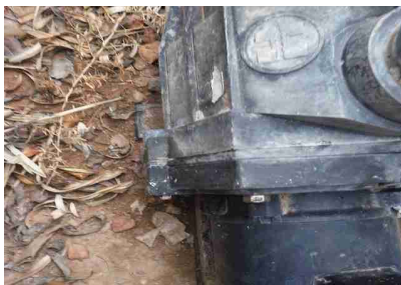
13.10 -The pool water features pump/motor was inspected and revealed the following adverse conditions as stated below and its is recommended that further repair be conducted by qualified pool contractor.

1. The motor is making an atypical sound which consistent with motor/pump that is nearing end of its service life.
2. The motor is not bonded as there is no visible conductor present.
3. There is an active at pump seal.
4. There is an active leak at Jandy valve.

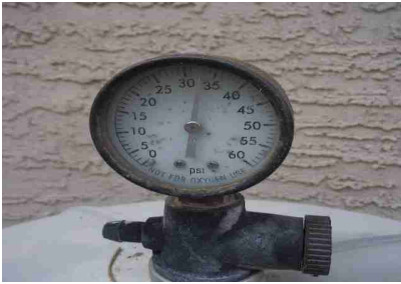
13.11 -The pool filter displayed a high pressure at 33 +psi which is atypically high for pool pressure and it is recommended that further examination and repair be conducted by a qualified pool contractor,

The pool filter displayed a high pressure indicating a need for service - *Continued*

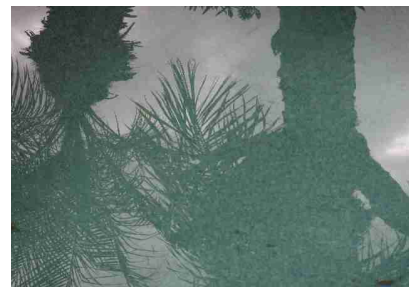
13.12 -There is DE residue in pool which is consistent with pool filter grids that have exceeded their service life and need to be replaced by a qualified pool contractor.

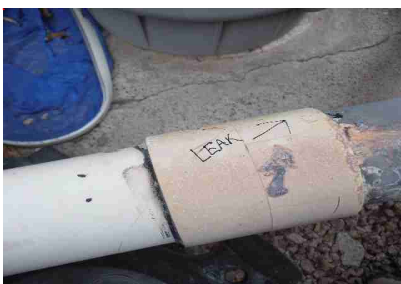
13.13 -There is a leak at the pool supply/return line coupler above pump/motor that needs to be repaired by a licensed pool contractor.

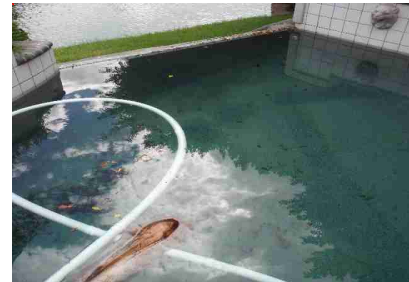
1. The south west Lion head is restricted and discharge a small stream of water in comparison to other heads.
2. The water fall additionally demonstrated a restricted flow when operated.

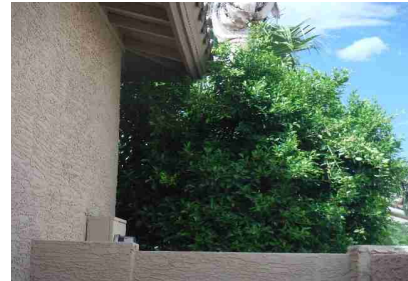
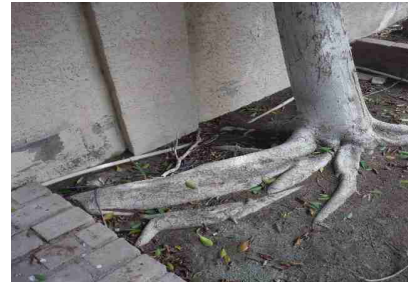
Additional Note: The ficus tree at south east exterior is pushing fence and additionally roots are growing under brick pavers. It may be necessary to remove tree to prevent further growth and potential damage to masonry perimeter fence.

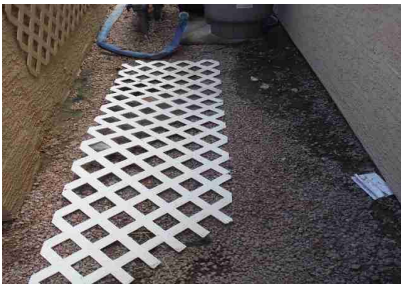
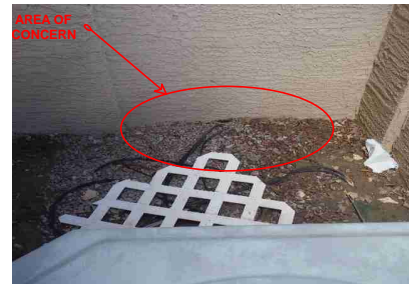
1. The east side exterior as there is no outlet for accumulated surface water as drain tile is obstructed by landscaping.

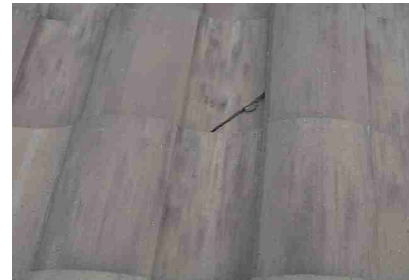
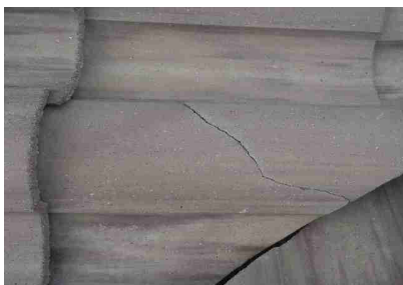
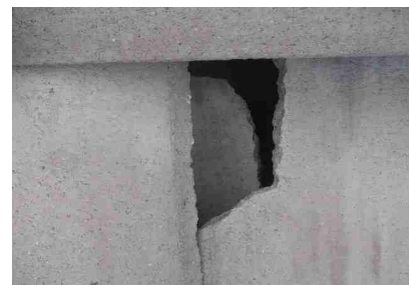
1. The east section of the roofs surface by deck.
2. The upper north east slope of the roofs surface.
3. The upper north east slope of the roofs surface.

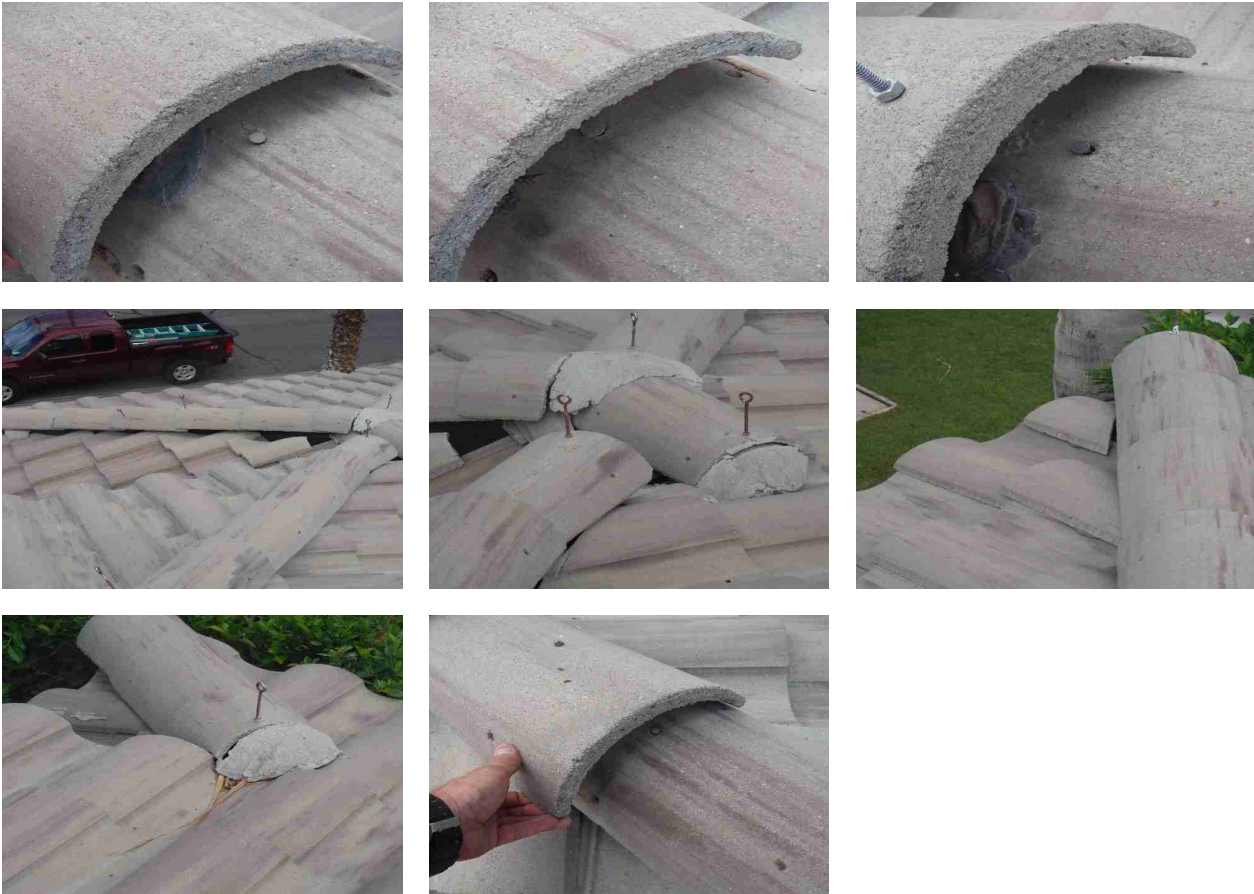
There are multiple displaced concrete roofing tiles located at the following locations on the roofs surface that are further exposing the roofs underlayment.

Note: The ridge tiles are not properly secured as tile adhesive is deteriorated from exposure to the elements and tiles can be moved using normal hand pressure. In addition, tiles were not nailed at any location that was checked; this includes all hip ridges and main ridge tiles.

Recommended Action: It is recommended that further examination and repair be conducted by a qualified roofing contractor.

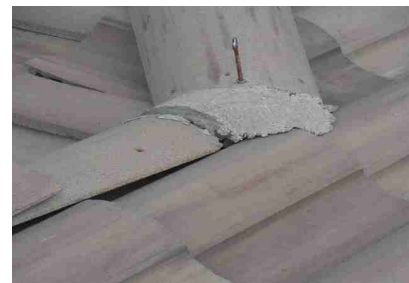
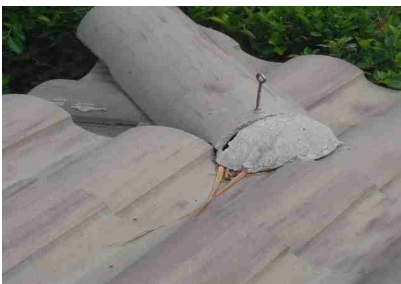
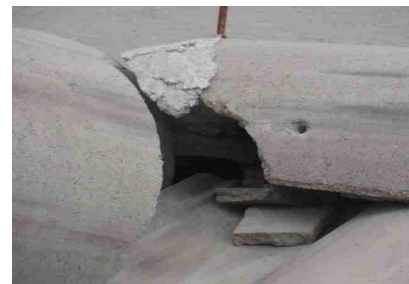
The majority of the mortar caps were observed to be cracked and separated and need to be repaired by a qualified roofing contractor

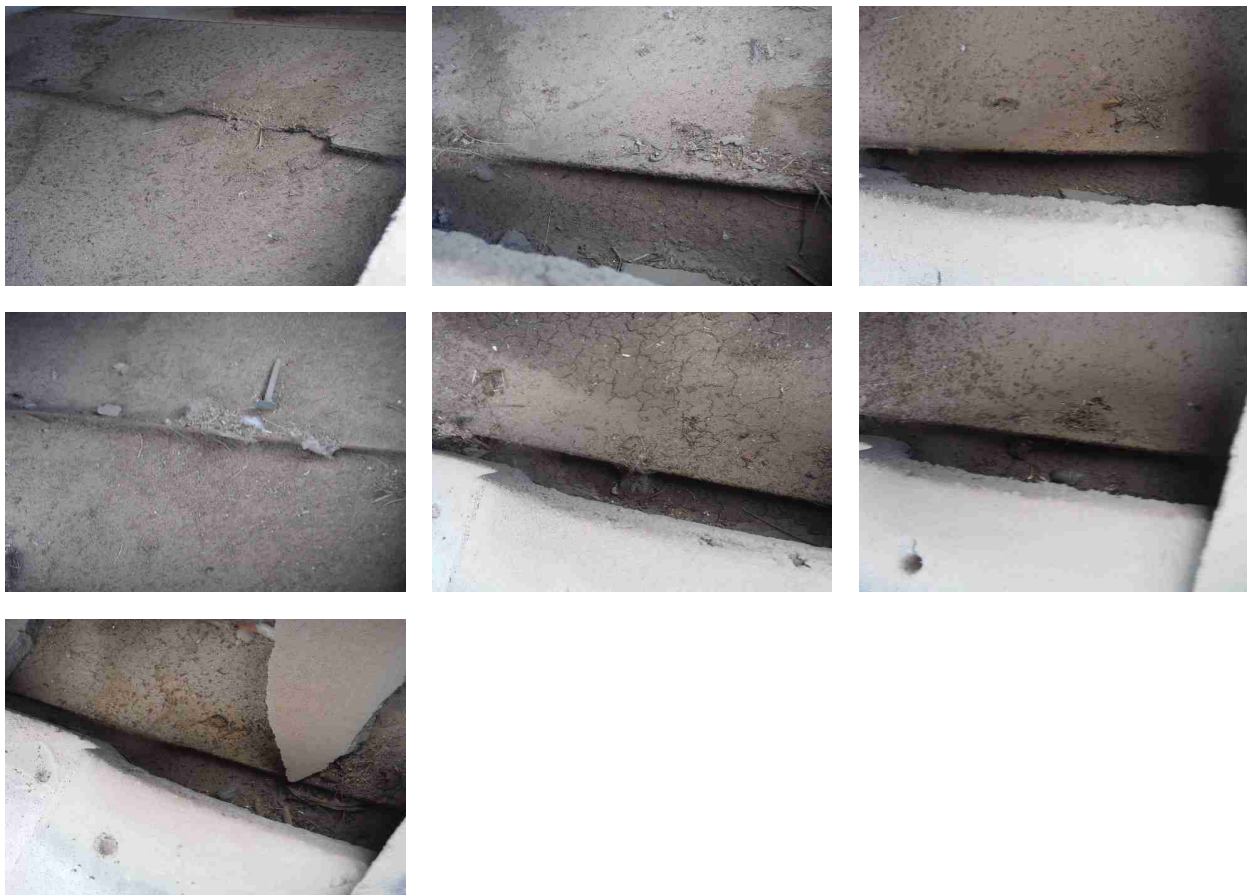
Note: There is moisture staining on living room ceiling as described in the inspection report and further corroborating the underlayment is not performing its intended function shedding water.

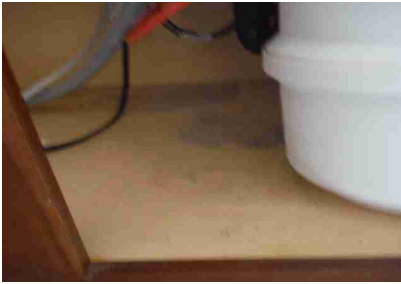
There is evidence of moisture damage under the kitchen sink - *Continued*

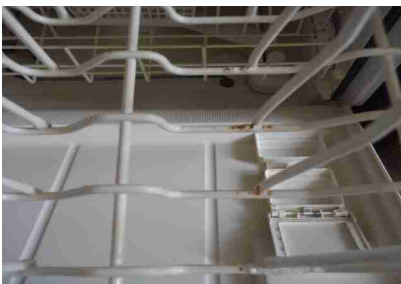
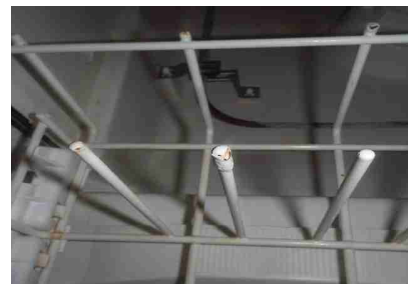
The dishwashers racks are rusting which is consistent with dish racks that have exceeded their service life and need to be replaced by a qualified appliance technician.

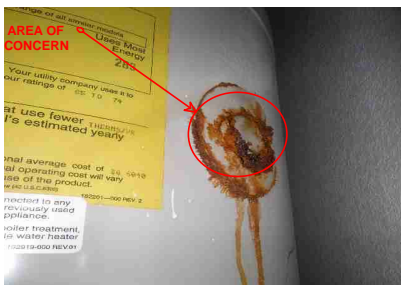
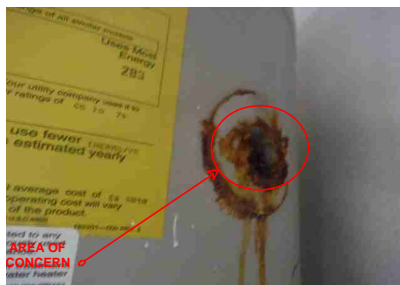
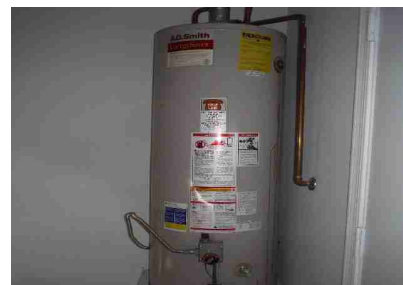
Note: The hot water heater is leaking intermittently as stated above therefore, when gas is activated and hot water heater is ignited the water heater may leak excessively as water heater has exceeded its service life.

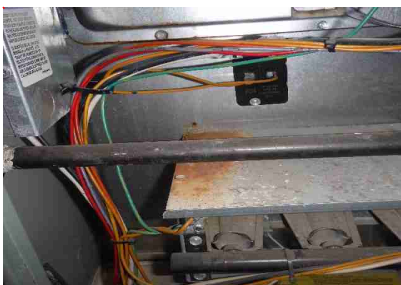
There is rust is combustion chamber of furnace which is consistent with an evaporator coil that is draining into the furnace and needs to be repaired by a qualified HVAC contractor.

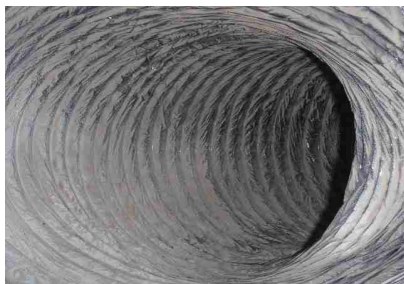
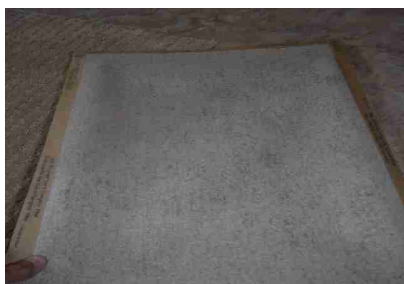
The return air compartment, grill and ducts are atypically dirty indicating a lack of normal routine maintenance and it is recommended that the return air compartment and all adjoining ducts be professionally cleaned by a qualified duct cleaning company to reduce the potential for damage to the HVAC and its related components.

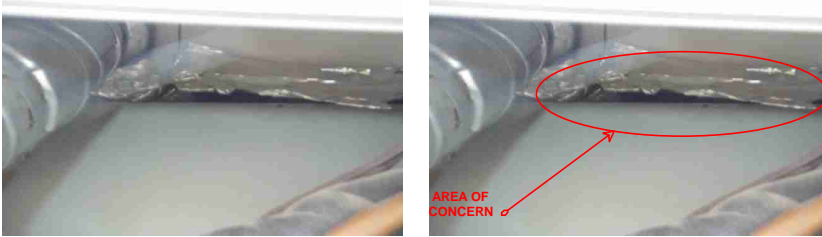
There is an ACTIVE air leak at the HVAC air handlers plenum that needs to be repaired by a qualified HVAC contractor to prevent further energy loss.

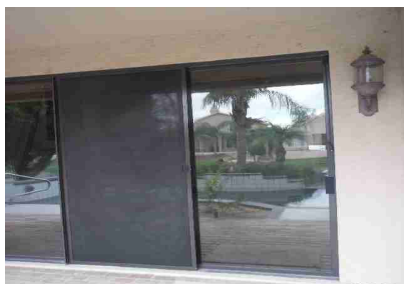
The exterior sliding glass doors self closing mechanism is not operational and needs to be repaired by a qualified pool door contractor to ensure the door is repaired and self closing/self latching as intended.

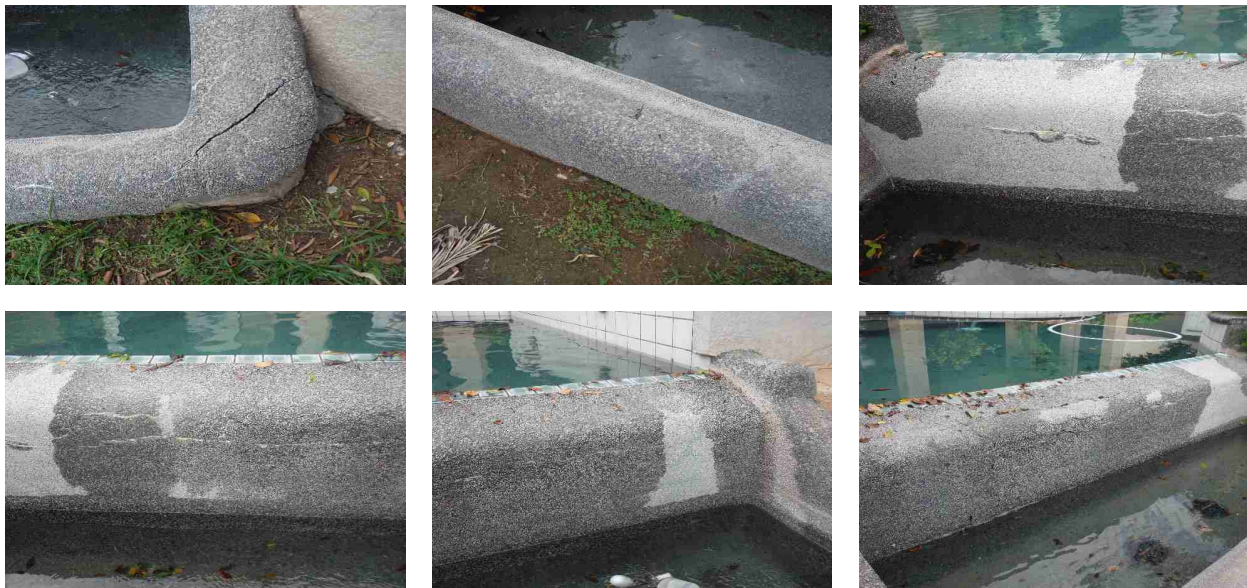
The pebble tech at the pools negative edge areas are severally damaged at multiple locations as there are cracks - *Contir*

Recommended Action: It is recommended that further examination of the pools pebble tech materiel be examined and repaired by a qualified pool contractor.

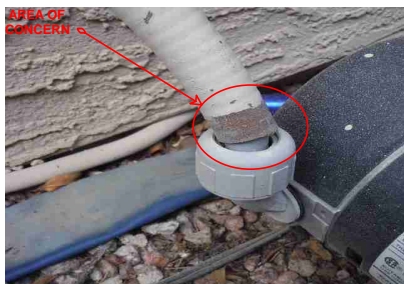
The pool motors electrical conduit is damaged/separated at motor and needs to be repaired by a qualified pool contractor.

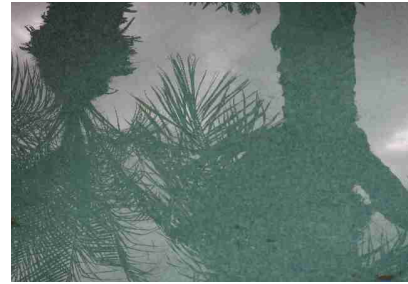
There is DE residue in pool which is consistent with pool filter grids that have exceeded their service life and need - *Conti*
