Sell Home Inspections Inc

SUMMARY REPORT

Inspection Address: 1234 Any Street, , Arizona 12345
Inspection Date: 9/15/2015 Start: 1:00 pm End: 4:30 pm
Weather: Overcast
Temperature: 90-100 Degrees

Inspected by: Rob Sell AZ Certification 38865

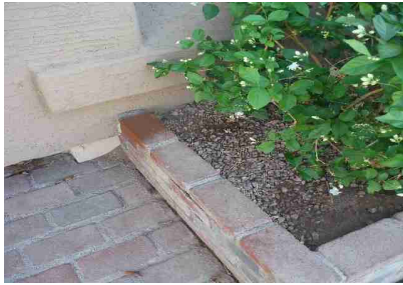
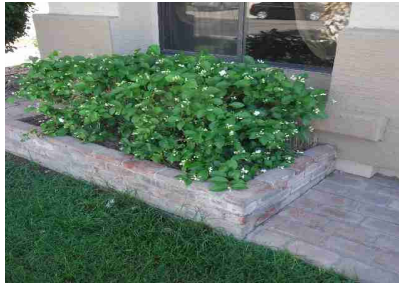
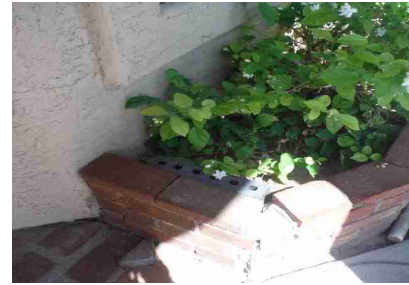
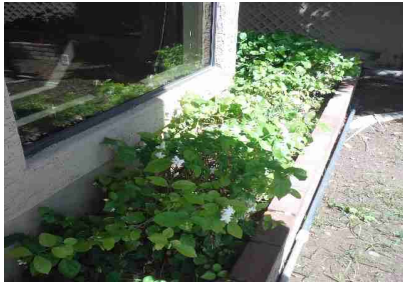
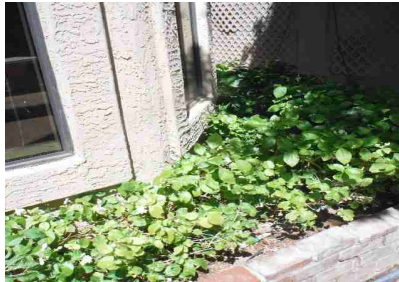
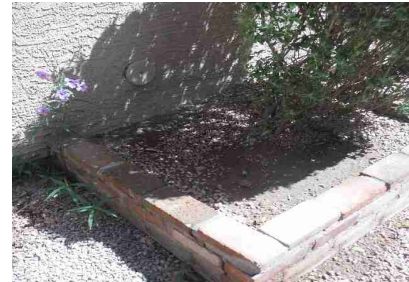
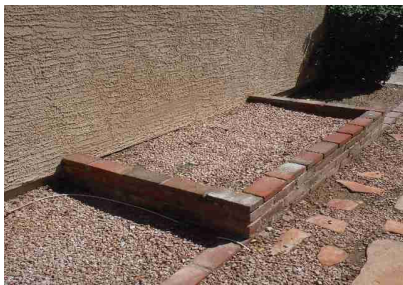
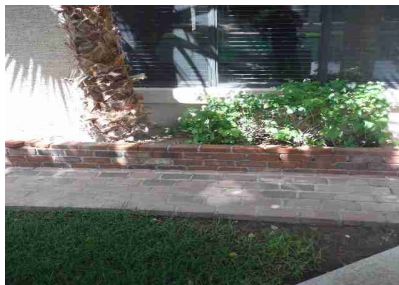
Location:

1. The north east flower bed enclosure.
2. The south side flower bed enclosures.
3. The south east and south west flower bed enclosures.

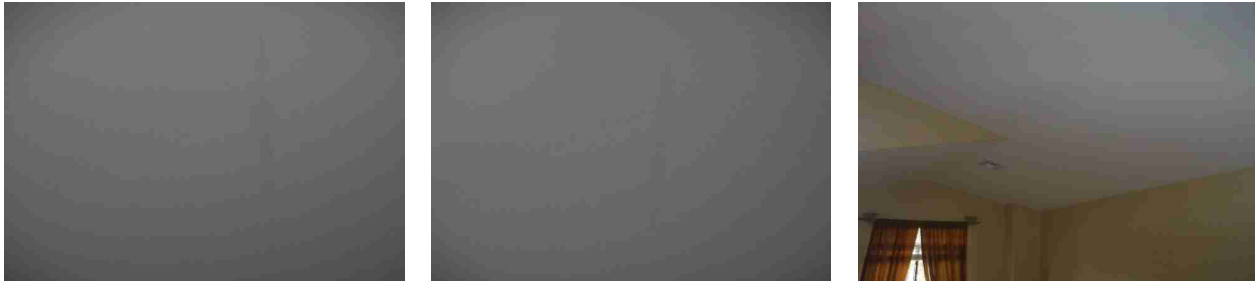
3.2 - There is moisture staining at the following interior locations which is consistent with an active roof leak and it is recommended that further repair be conducted by a qualified roofing contractor.

1. The north east family room ceiling.

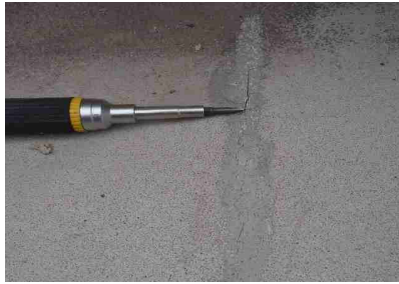
3.3 - The view deck covering material is cracked and separated at the seams at multiple locations on the decks surface. This is consistent with a deck coating that has exceeded its service life and it is recommended that the service of a qualified roofing contractor be retained to examine the deck coating and all related deck components in its entirety and further make all necessary repairs, modifications and corrective measures needed.

The view deck covering material is cracked and separated at the seams - *Continued*

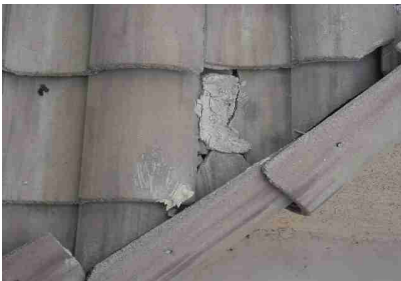
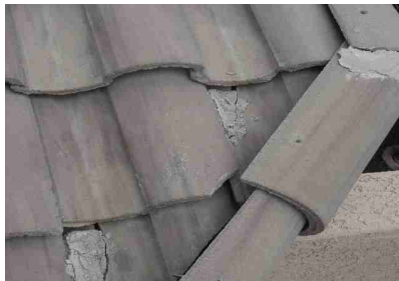
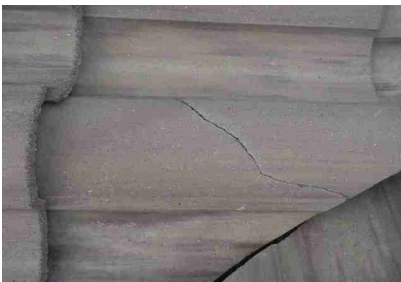
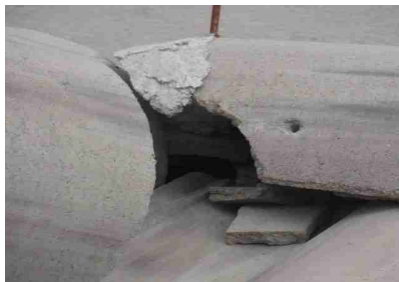
3.4 - There are multiple damaged concrete roofing tiles located at the following locations that needs to be repaired or replaced by a qualified contractor.

1. The east section of the roofs surface by deck.
2. The upper north east slope of the roofs surface.
3. The upper north east slope of the roofs surface.

Note: It is additionally recommended that the underlayment in the close proximity of the damaged tiles be evaluated and replaced as deemed necessary.

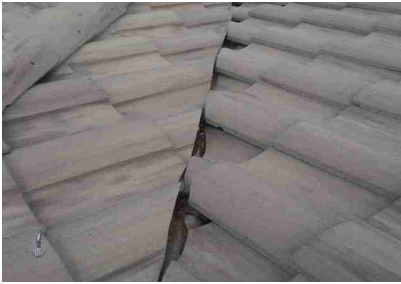
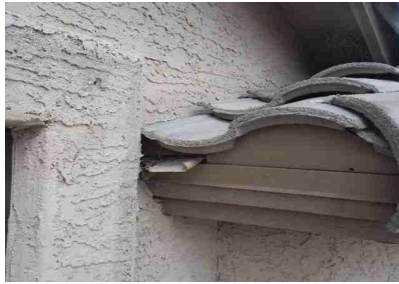
1. The upper south west valley.
2. The south east valley at headwall by view deck.

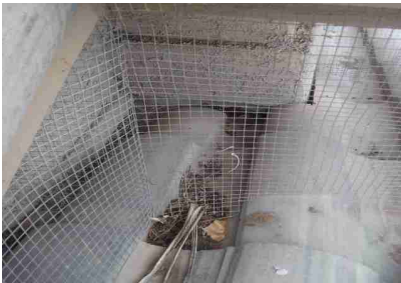
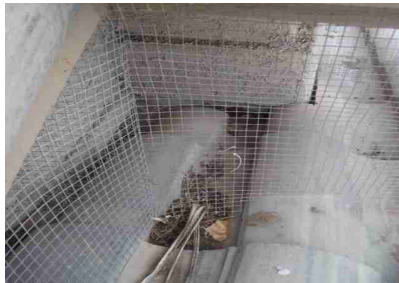
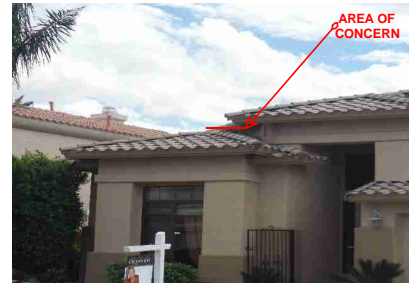
1. The upper north east dead valley at area blocked off with wire.

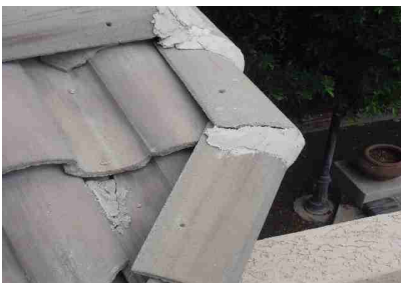
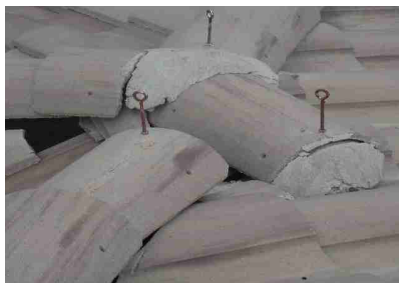
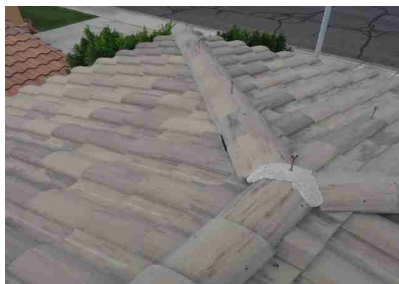
3.11 - The majority of the mortar caps were observed to be cracked and separated and need to be repaired by a qualified roofing contractor

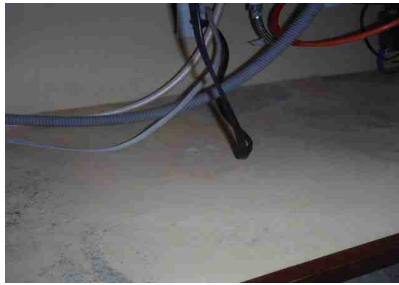
4.2 - There is evidence of moisture damage under the kitchen sink indicating which is consistent with a past leak. However, the extent of the damage could not be definitively determined as the concealed areas under the basin, and behind the walls cannot be observed. Therefore, it is recommended that measures be taken to retain a qualified contractor to repair the under sink basin area and all related cabinets and wall components in their entirety and further as deemed necessary. This may include but is not limited to a mold test if deemed necessary.

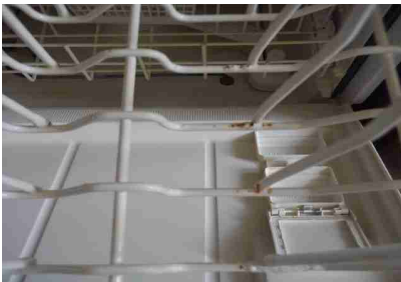
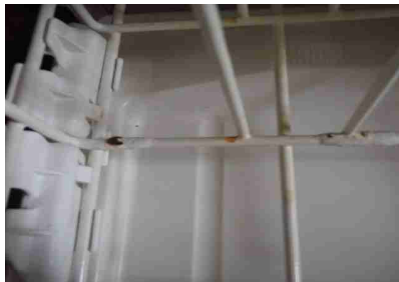
4.3 - The dishwashers racks are rusting which is consistent with dish racks that have exceeded their service life and need to be replaced by a qualified appliance technician.

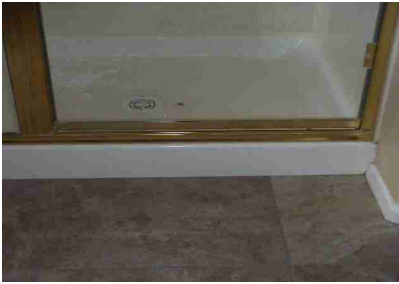
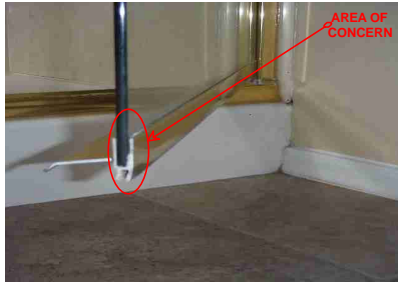
4.4 - The stall shower doors lower door sweep is damaged and needs to be replaced by a qualified contractor to reduce the potential for water to enter under the door.

The stall shower doors lower door sweep is damaged and needs to be repalced by a qualified contractor - *Continued*

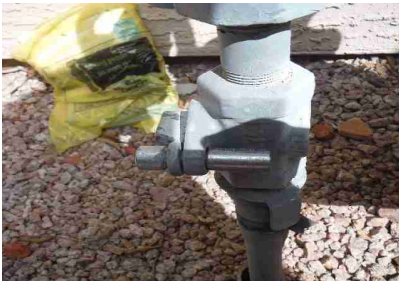
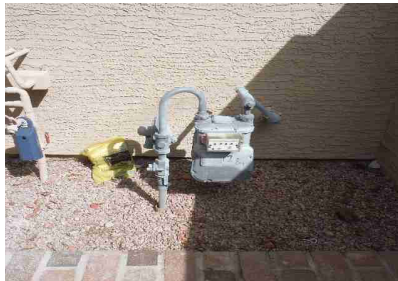
4.6 - The gas is off at the main. The gas company must be contacted to turn it on and safety check ALL of the gas appliances. Therefore, this prevented ALL OF THE GAS FIRED APPLIANCES from being inspected for operation. A visual inspection was made of the all of the gas fired appliances with no adverse conditions observed at the time of the inspection. It is recommended that the gas be turned on and all gas fired appliances be inspected and tested for operation prior to customer taking possession of the subject property.

1. The natural gas hot water heater.
2. The natural gas furnaces."Both"

Note: The gas service provider typically checks all gas fired appliances for leaks and defects during the activation process, therefore, if an adverse condition is discovered the gas will not be activated until all adverse conditions are repaired. This is to ensure customer safety.

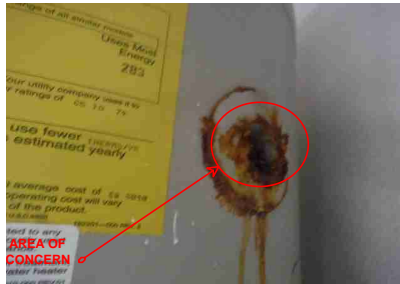
- 4.9 - There is **EXCESSIVE** rust at the upper drain plug of the hot water heater which is consistent with a water heater that is leaking intermittently and has exceeded its serviceable life.. This is an Immediate attention Item and it is recommended that the services of licensed plumbing contractor be retained to examine the water heater and to make the necessary repairs, modifications and corrective measures to include a total replacement of the water heater if deemed necessary.

Note: The hot water heater is leaking intermittently as stated above therefore, when gas is activated and hot water heater is ignited the water heater may leak excessively as water heater has exceeded its service life.

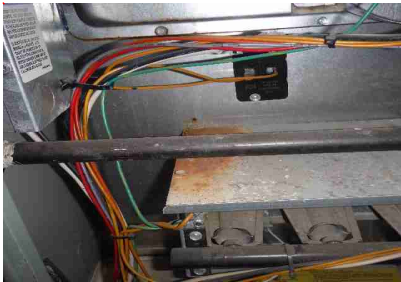
7.3 - There is rust is combustion chamber of furnace which is consistent with an evaporator coil that is draining into the furnace and needs to be repaired by a qualified HVAC contractor.

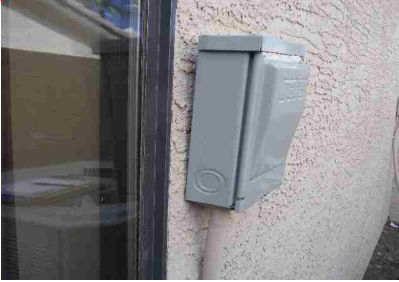
7.8 - The HVAC service disconnect assembly is not properly secured to the exterior and disrupts service when the panel door is opened and closed and further presents the potential for a shock hazard.
Recommended Action: It is recommended that further examination and repair be conducted by a qualified HVAC contractor.

The HVAC service disconnect assembly is not properly secured to the inner panel and disrupts service - *Continued*

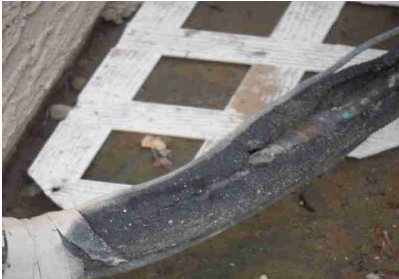
7.15 - Insulation is missing or deteriorated at the refrigerant lines at the condenser and needs to be replaced to operate and insulate the lines as intended.

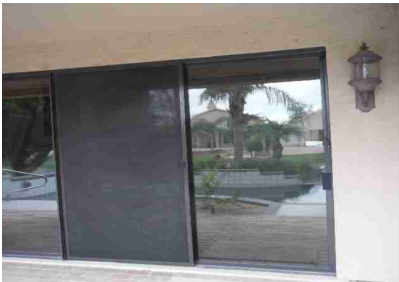
13.2 - The exterior sliding glass doors self closing mechanism is not operational and needs to be repaired by a qualified pool door contractor to ensure the door is repaired and self closing/self latching as intended.

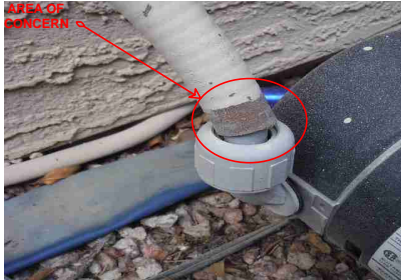
13.9 - The pool motors electrical conduit is damaged/separated at motor and needs to be repaired by a qualified pool contractor.

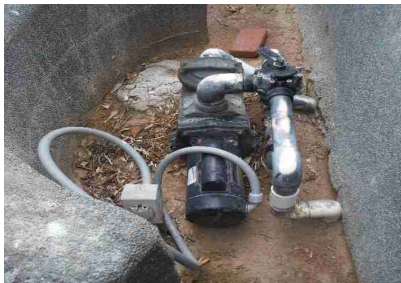
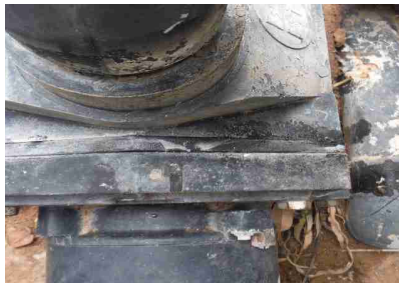
13.10 -The pool water features pump/motor was inspected and revealed the following adverse conditions as stated below and its is recommended that further repair be conducted by qualified pool contractor.

1. The motor is making an atypical sound which consistent with motor/pump that is nearing end of its service life.
2. The motor is not bonded as there is no visible conductor present.
3. There is an active at pump seal.
4. There is an active leak at Jandy valve.

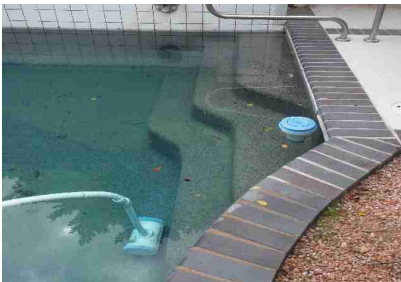
13.12 -There is DE residue in pool which is consistent with pool filter grids that have exceeded their service life and need to be replaced by a qualified pool contractor.

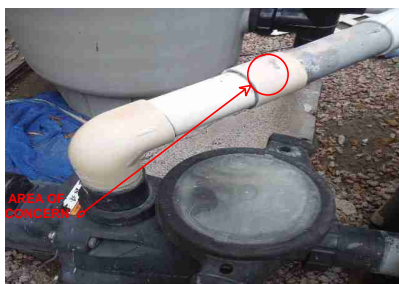
13.13 -There is a leak at the pool supply/return line coupler above pump/motor that needs to be repaired by a licensed pool contractor.

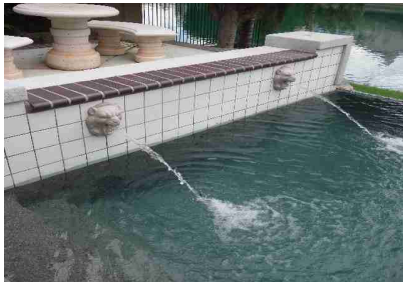
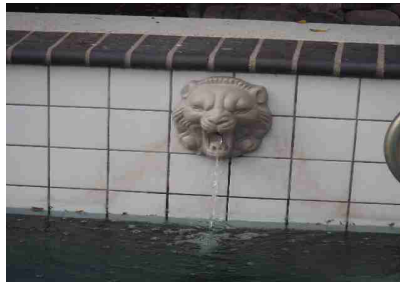
13.15 -The water feature heads were inspected an revealed the following adverse conditions as stated below and it is recommended that further examination repair be conducted by qualified pool contractor.

1. The south west Lion head is restricted and discharge a small stream of water in comparison to other heads.
2. The water fall additionally demonstrated a restricted flow when operated.

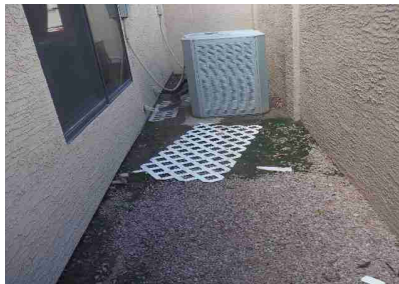
Locations:

1. The east side exterior as there is no outlet for accumulated surface water as drain tile is obstructed by landscaping.

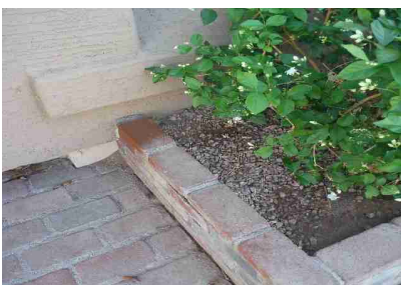
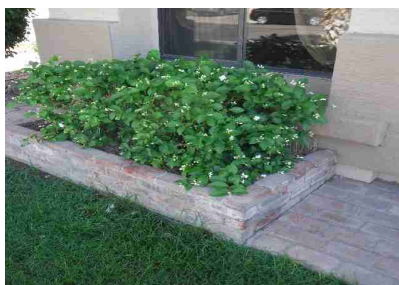
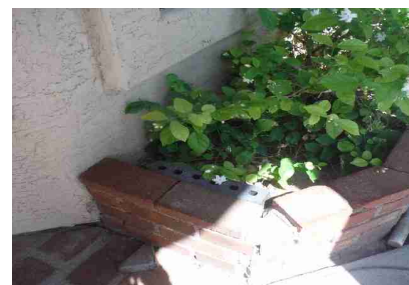
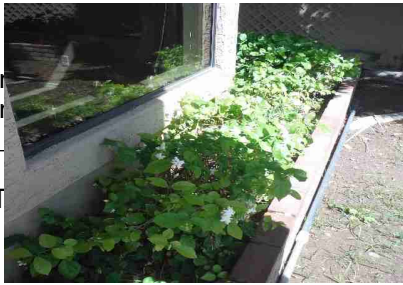
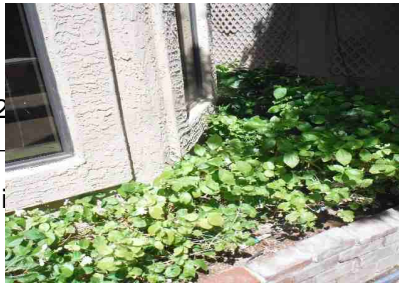
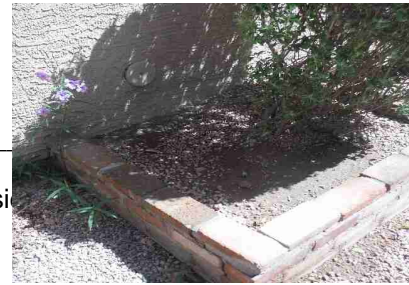
The grading inside of the flower beds at the following locations are in direct contact with the stucco siding which increases the potential for moisture intrusion into the residence. In addition, when grading is in direct contact with the exterior wall cladding it further presents a condition conducive to wood destroying organisms. It is recommended that the services of a qualified contractor be retained to examine the noted adverse condition and make the necessary repairs, modifications or corrective measures needed to ensure the grading is not in direct contact with the exterior wall cladding material. This may include but is not limited to the removal of the grading in its entirety or placing an industry standard approved barrier between the grading and the exterior wall cladding material.

Location:

1. The north east flower bed enclosure.
2. The south side flower bed enclosures.
3. The south east and south west flower bed enclosures.

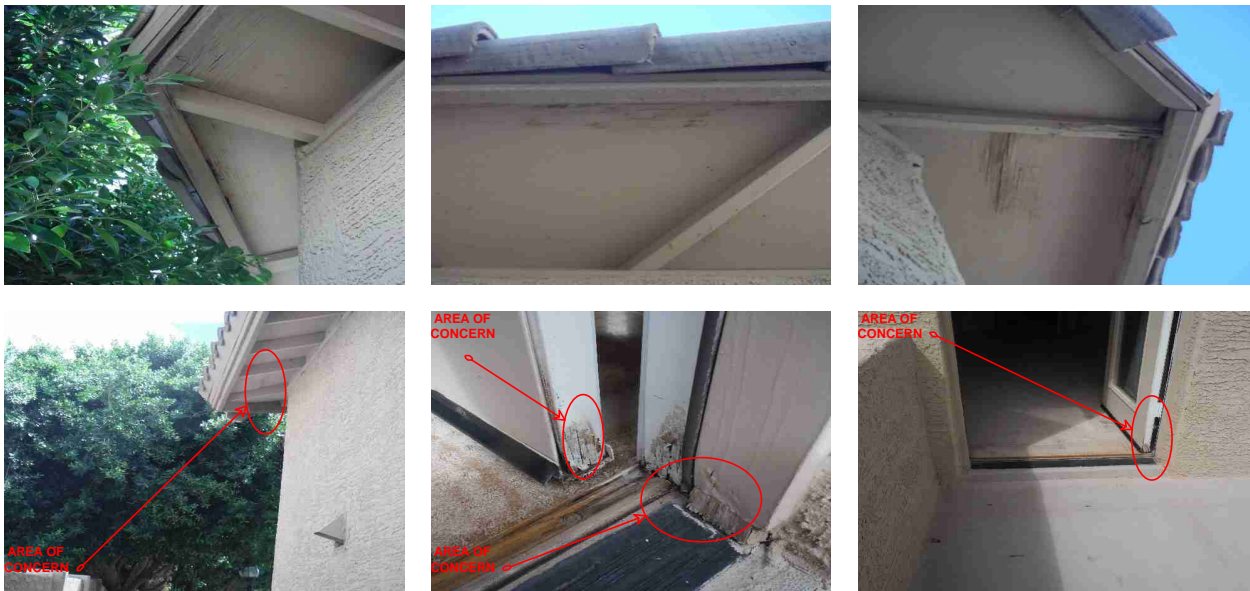
1. The south east roof sheathing.
2. The south side roof sheathing.

- 3. The south side roof sheathing and rafter tail.
- 4. The upstairs deck entry doors and lower jamb.

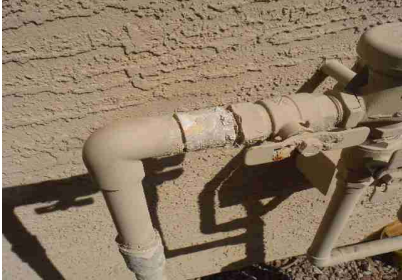
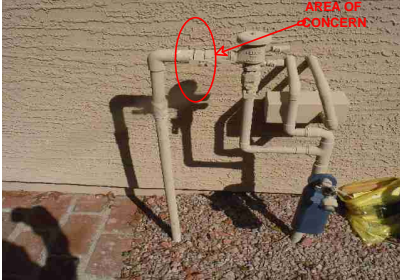
There is leak at the water distribution pipe where it is attached to the vacuum breaker that needs to - *Continued*

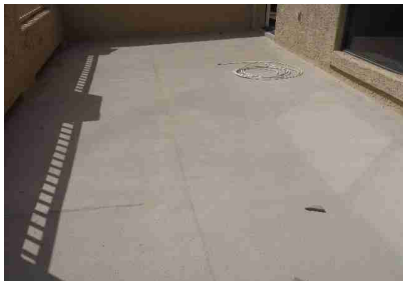
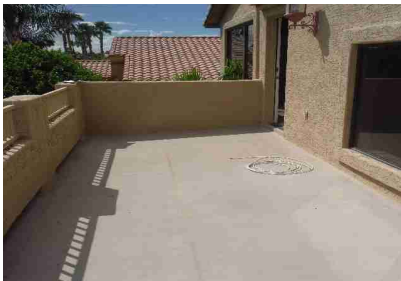
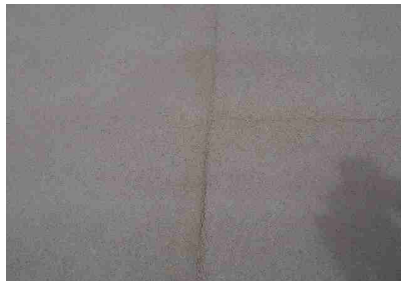
The view deck covering material is cracked and separated at the seams at multiple locations on the decks surface. This is consistent with a deck coating that has exceeded its service life and it is recommended that the service of a qualified roofing contractor be retained to examine the deck coating and all related deck components in its entirety and further make all necessary repairs, modifications and corrective measures needed.

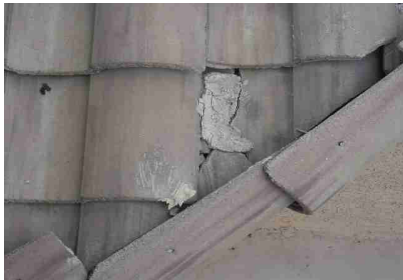
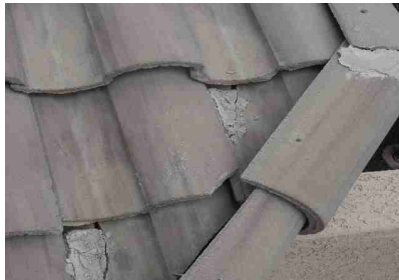
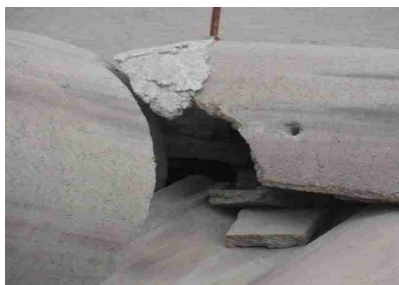
Locations:

1. The east section of the roofs surface by deck.
2. The upper north east slope of the roofs surface.
3. The upper north east slope of the roofs surface.

There are multiple displaced concrete roofing tiles located at the following locations on the roofs surface that are further exposing the roofs underlayment.

Recommended Action: It is recommended that further examination and repair be conducted by a qualified roofing contractor.

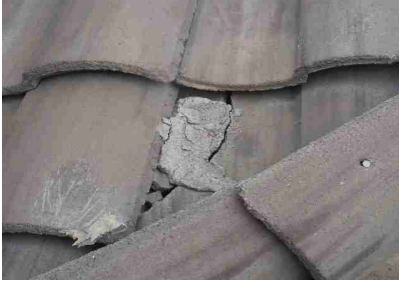
The majority of the mortar caps were observed to be cracked and separated at - *Continued*

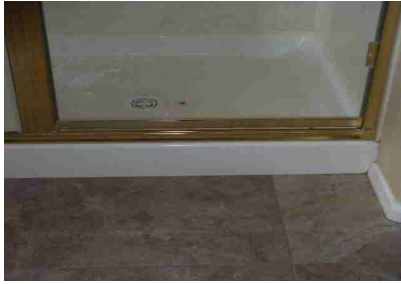
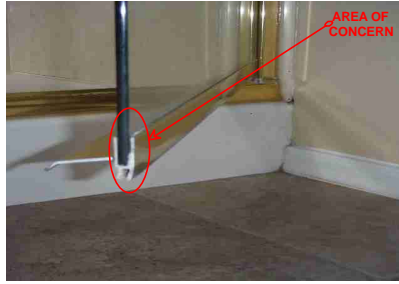
The stall shower doors lower door sweep is damaged and needs to be replaced by a qualified contractor to reduce the potential for water to enter under the door.

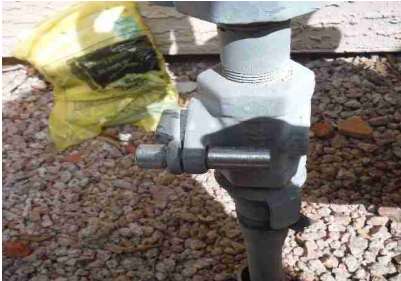
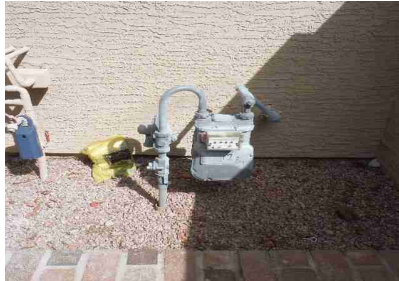
1. The natural gas hot water heater.
2. The natural gas furnaces."Both"

Note: The gas service provider typically checks all gas fired appliances for leaks and defects during the activation process, therefore, if an adverse condition is discovered the gas will not be activated until all adverse conditions are repaired. This is to ensure customer safety.

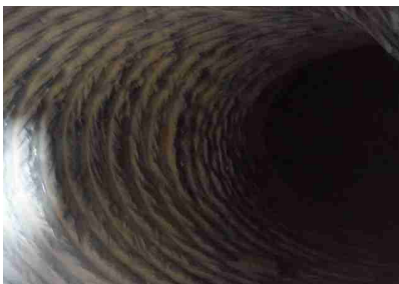
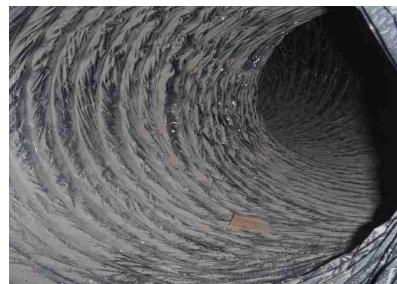
The return air compartment, grill and ducts are atypically dirty indicating a lack of normal routine maintenance and it is recommended that the return air compartment and all adjoining ducts be professionally cleaned by a qualified duct cleaning company to reduce the potential for damage to the HVAC and its related components.

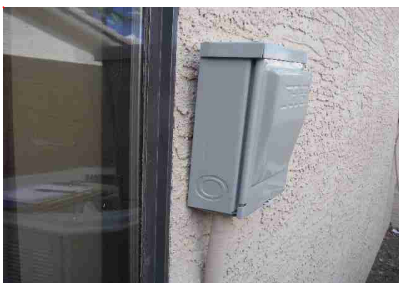
The HVAC service disconnect assembly is not properly secured to the exterior and disrupts service when the panel door is opened and closed and further presents the potential for a shock hazard.

Recommended Action: It is recommended that further examination and repair be conducted by a qualified HVAC contractor.

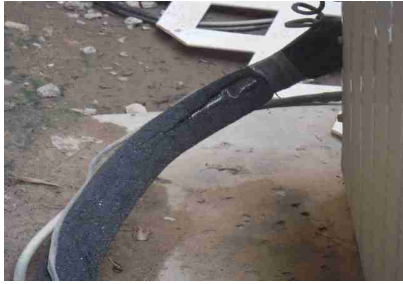
Insulation is missing or deteriorated at the refrigerant lines at the condenser and needs to be replaced to operate and insulate the lines as intended.

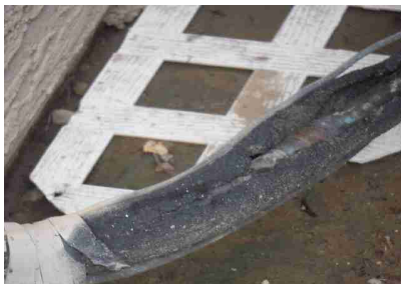
Insulation is missing or deteriorated at the refrigerant lines at the condenser and needs to be replaced to operate and insulate the lines as intended.

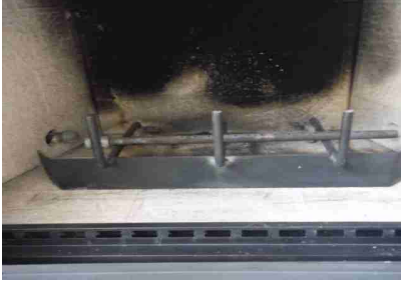
The natural gas fireplace burner has not been installed therefore the fireplace is incomplete - *Continued*

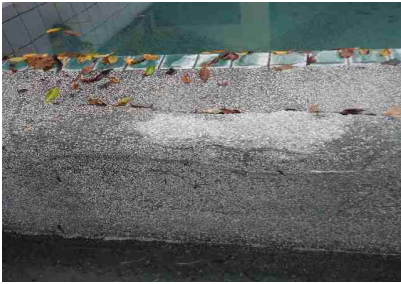
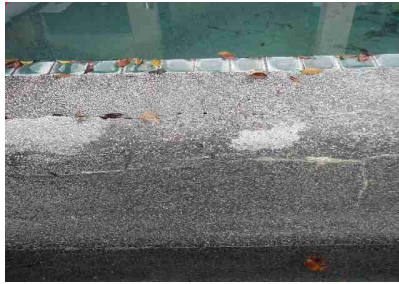
The pebble tech at the pools negative edge areas are severally damaged at multiple locations as there are cracks - *Contir*

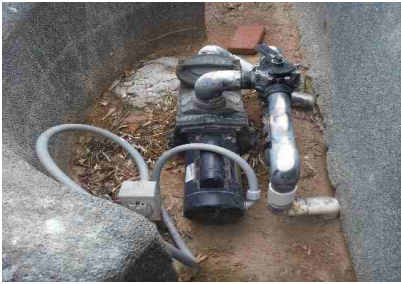
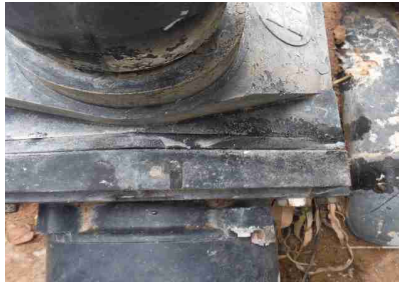
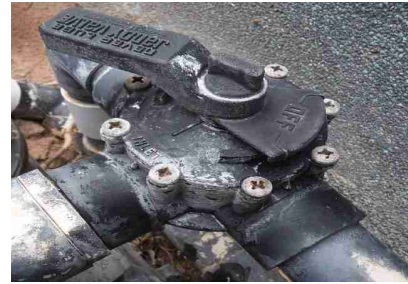
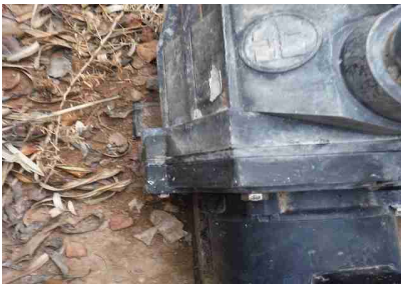
The pool water features pump motor was inspected and revealed - *Continued*

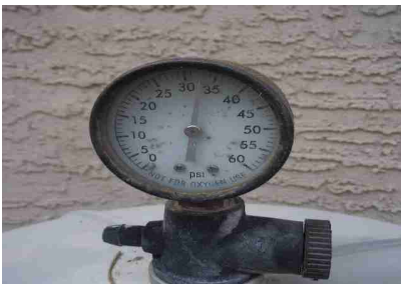
The pool filter displayed a high pressure at 33 +psi which is atypically high for pool pressure and it is recommended that further examination and repair be conducted by a qualified pool contractor,
Note: Normal pool pressure is typically between 12-15 psi.

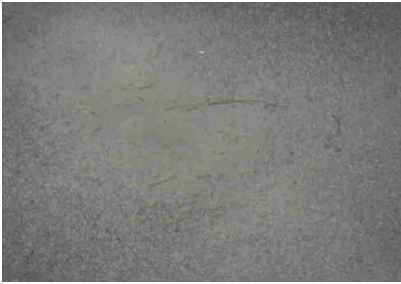
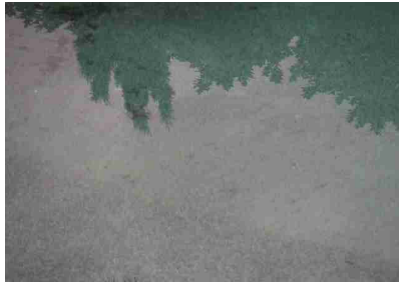
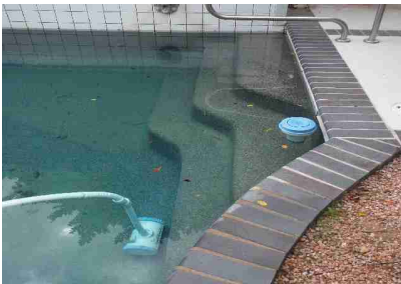
There is DE residue in pool which is consistent with pool filter grids that have exceeded their service life and need to be replaced by a qualified pool contractor.

There is DE residue in pool which is consistent with pool filter grids that have exceeded their service life and need - *Conti*

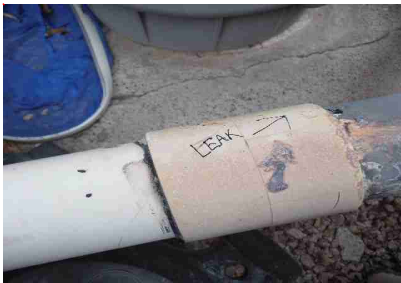
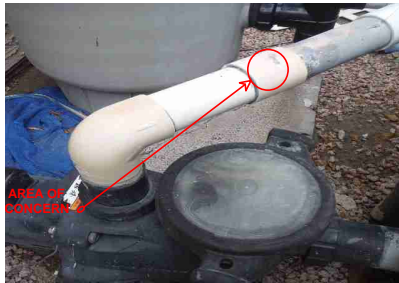
There is a leak at the pool supply/return line coupler above pump/motor that needs to be repaired by a licensed pool contractor.

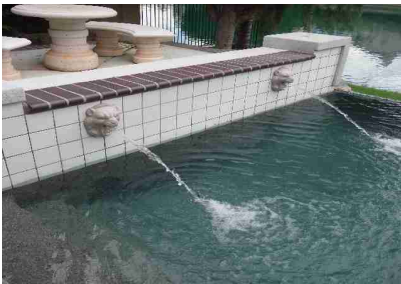
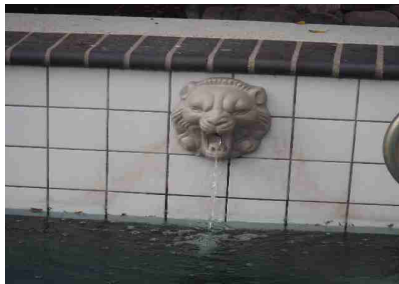
The water feature heads were inspected an revealed the following adverse conditions as stated below and it is recommended that further examination repair be conducted by qualified pool contractor.

1. The south west Lion head is restricted and discharge a small stream of water in comparison to other heads.
2. The water fall additionally demonstrated a restricted flow when operated.
